Subject: Issuance of Findings of Violation and Order for Compliance for NPDES Permit Violations

Exhibit 1
Marisco, Ltd.
NPDES Permit No. HI0021786
Drydock Cycling Effluent Limitation Violations
April 2007 – November 2008

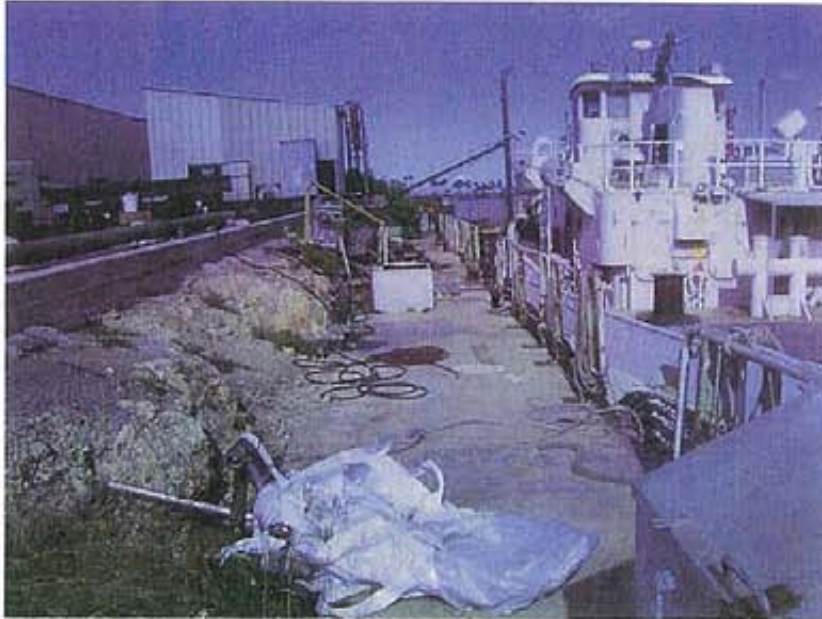
Photo 1: This photograph provides an overview of the dock, beyond the containment berm and on the edge of the water. This photograph is taken facing northwest. This area appeared to be used mostly as a walk way to the docked vessels, however observations during the inspection suggest that at a minimum, temporary or short-term storage of materials, including petroleum products, occurs at this location.

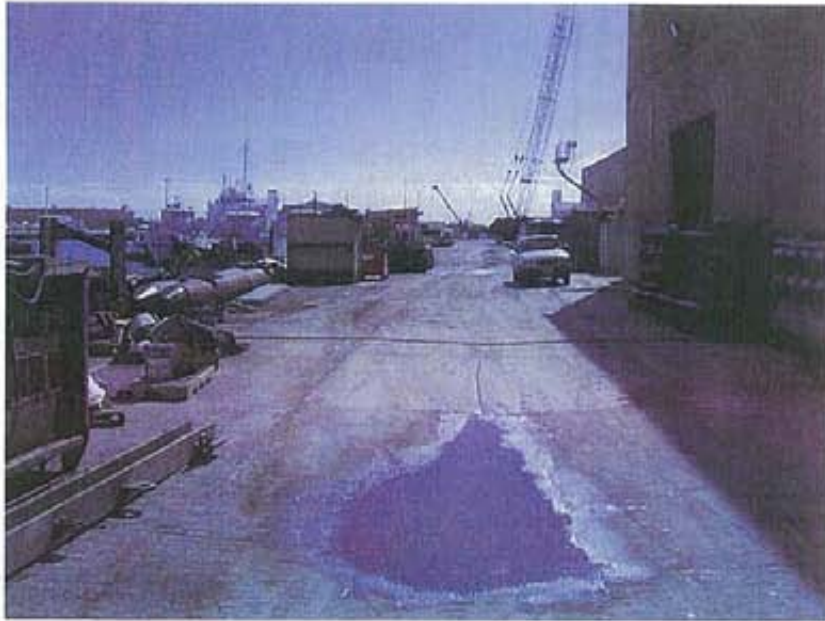
Photo 2: This photograph provides an overview of the main yard from approximately 3/4ths of the way down the southeast side. The Facility representative stated that most of the rainfall that occurs on-site is collected in the middle of the yard in three dry wells. The Facility representative was unsure of the volume of the dry wells. The gradient of the concreted area does suggest that the majority of the rainfall would drain toward the center of the main yard and into the dry wells. However, the gradient of the main yard near the bermed area was not apparent, and evidence of flow through gaps in the berm were observed during the inspection.

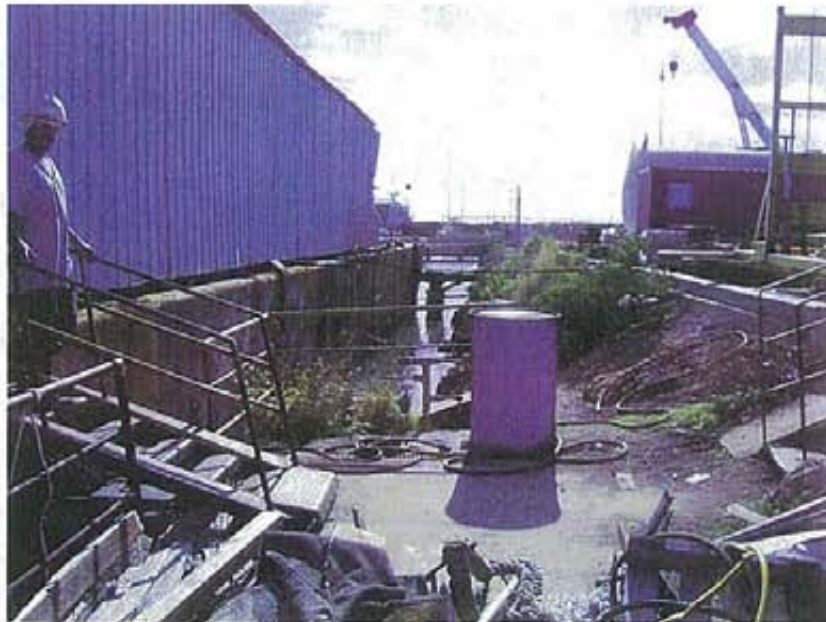
Photo 4: This photograph provides an overview of the dock, beyond the containment berm on the edge of the water, between the "Working Barge" and "JR's Area". This photograph is taken facing southeast. The 55-gallon drum pictured above is a spill kit.

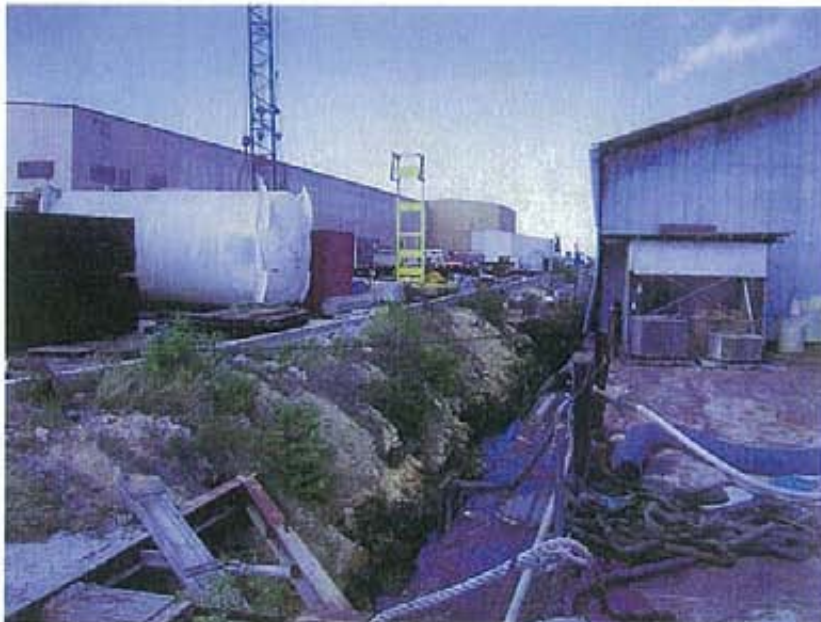
Photo 5: This photo was taken from the on-site "work barge", and depicts the drop-off from the bermed areas of the Facility directly into the receiving water. This is typical of the area referred to as "JR's Area" (area pictured above), and the portion of the main yard at the northwest end of the Facility, beyond the dockside walk way.

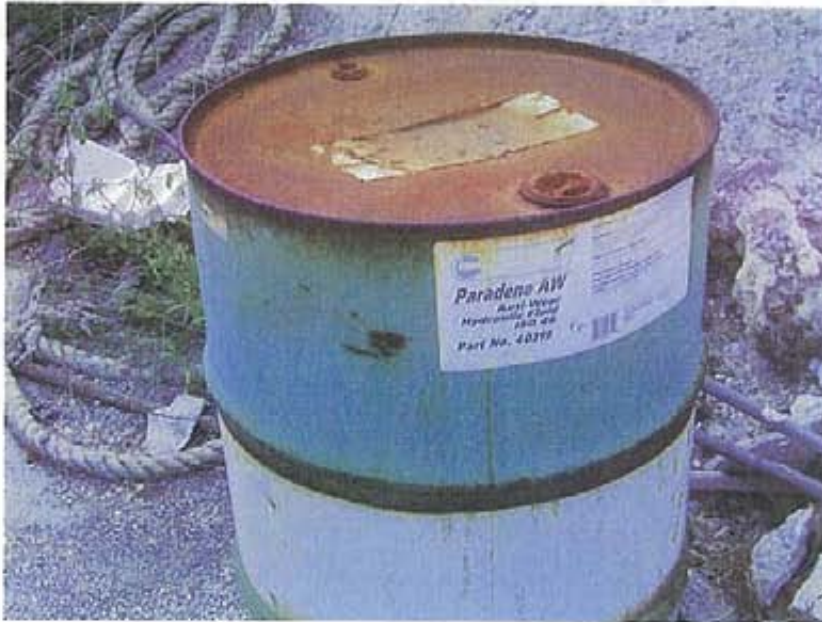
Photo 6: A 55-gallon drum of hydraulic fluid was observed on-site, adjacent to the receiving water, without secondary containment.

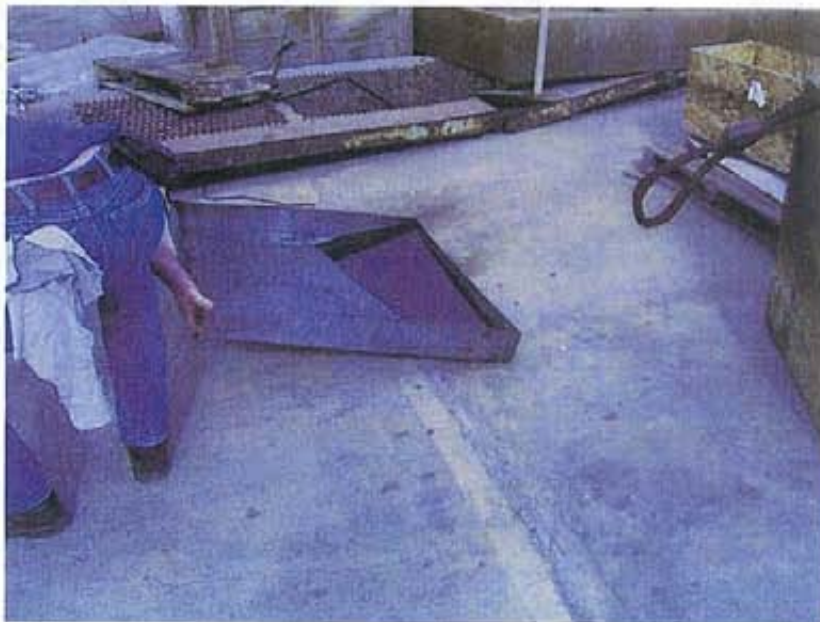
Photo 7: Unidentified liquid contained in a "make-shift" drip pan, resembling other petroleum products observed on-site, in the main yard adjacent to the berm surrounding the main yard.

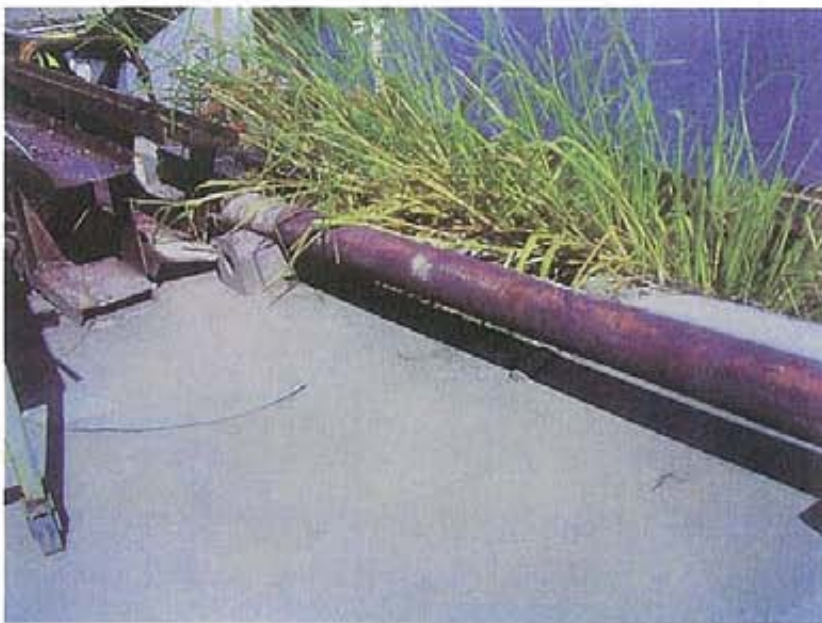
- a. Berms around the main yard, a portion of Marisco's Main Facility referred to as "JR's area", and the storage area behind the main yard were observed to have breaches, discharge structures, or areas that lacked containment, resulting in potential storm water discharge locations;

Photo 8: A break in the berm for the main yard.

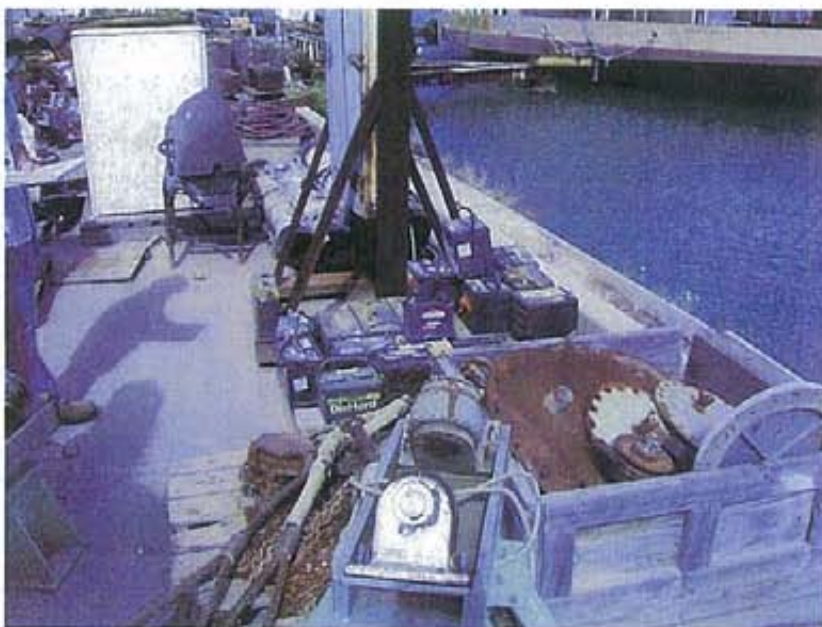
Photo 9: A pallet of used batteries stored in the main yard, adjacent to the berm around the main yard. A drainage hole in the berm was observed down gradient of this location (see Photo 9).

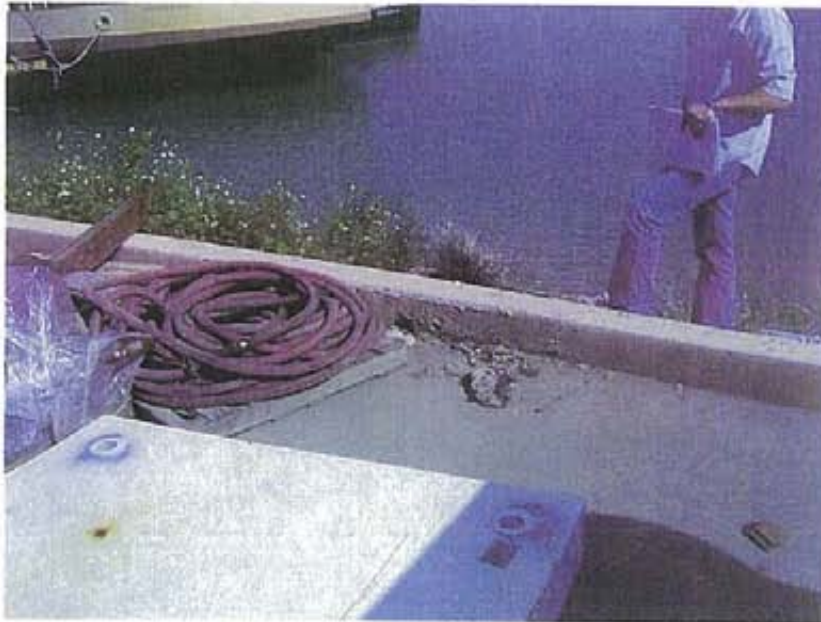
Photo 10: A drainage hole in the berm of the main yard, down gradient of the pallet of used batteries.

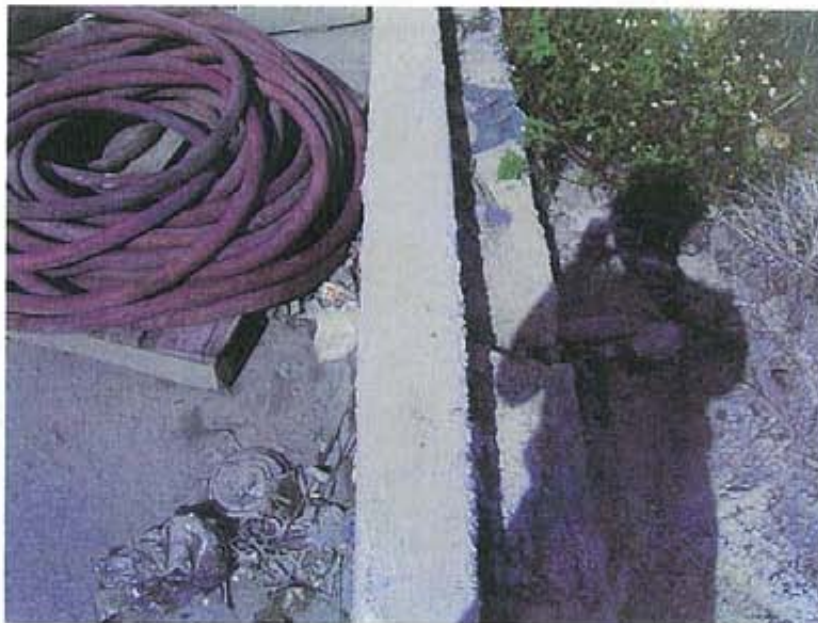
Photo 11: Debris and silt were observed around the drainage hole in the berm. Signs of erosion were observed on the water's side of the berm, indicating that discharges from this drainage hole have occurred. Flow through this discharge location would flow down the bank and directly into the receiving water.

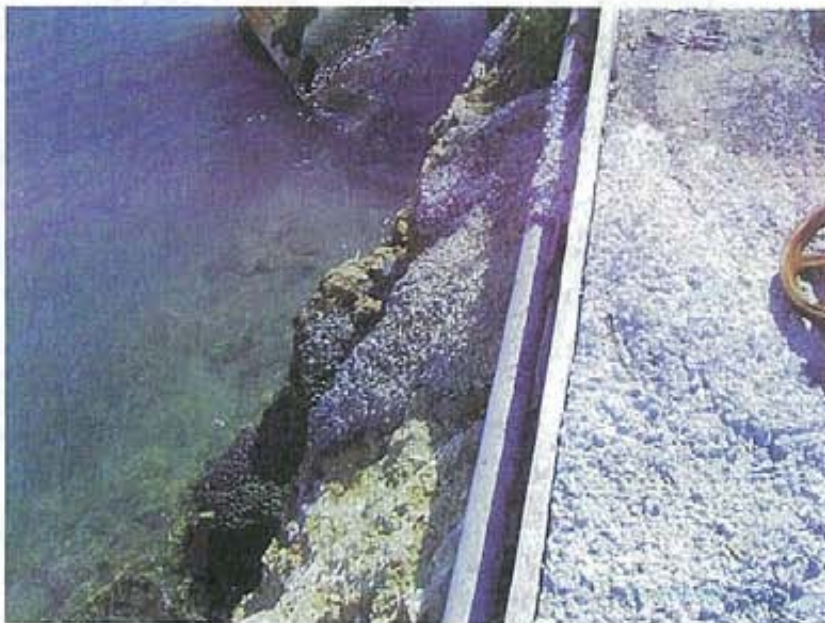
- c. The Discharger had recently concreted portions of the main yard, JR's area, and the storage area behind (northeast of) the metal working building. The inspectors noted that concrete had not been properly contained, including in some cases overflowing into the receiving water;

Photo 12: An ongoing construction project was observed on-site. Evidence of concrete spillage into the receiving water was observed on-site.

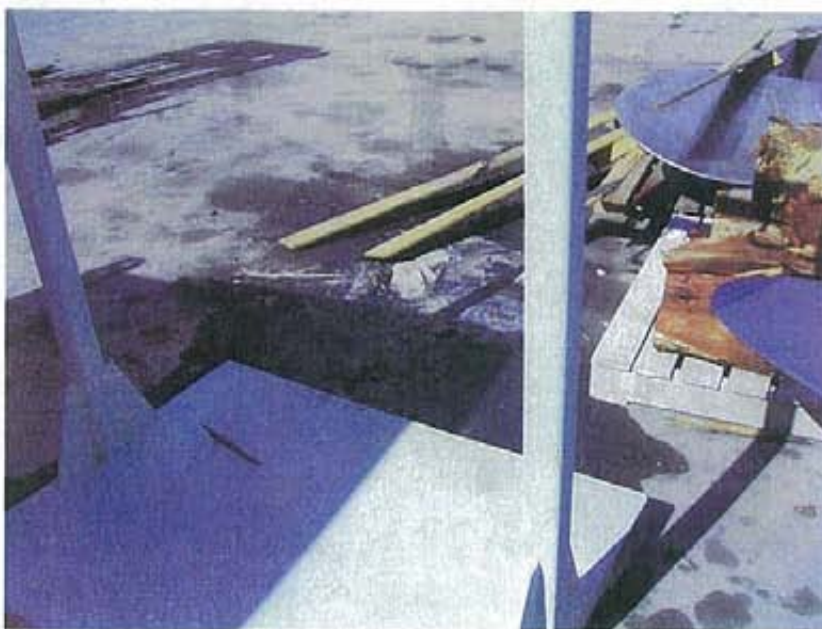
Photo 13: Signs of spillage and staining were observed in portions of the main yard.

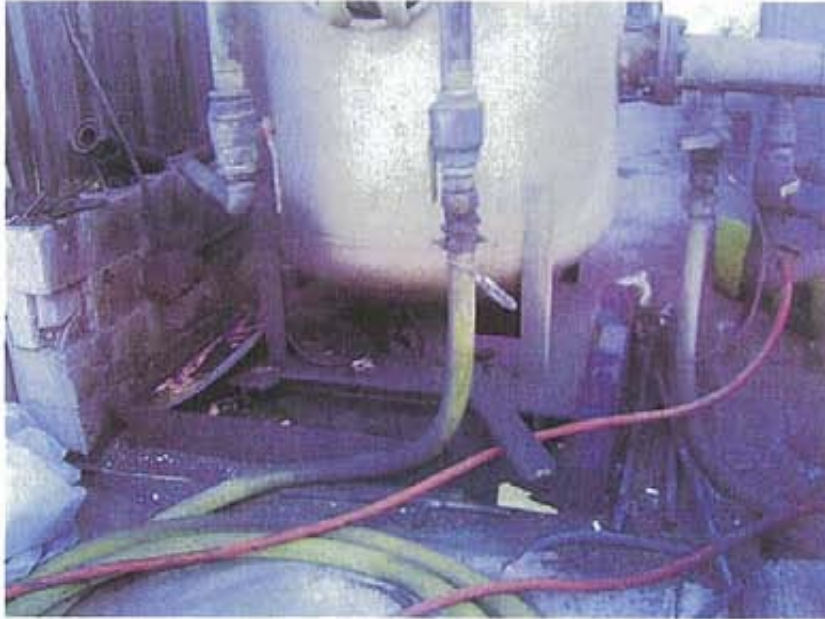
Photo 16: A drip pan for an air receiver located beside the metal working building full of a mixture of oil and condensate was observed. The drip pan was uncovered, exposed to potential rain fall, and without additional containment.

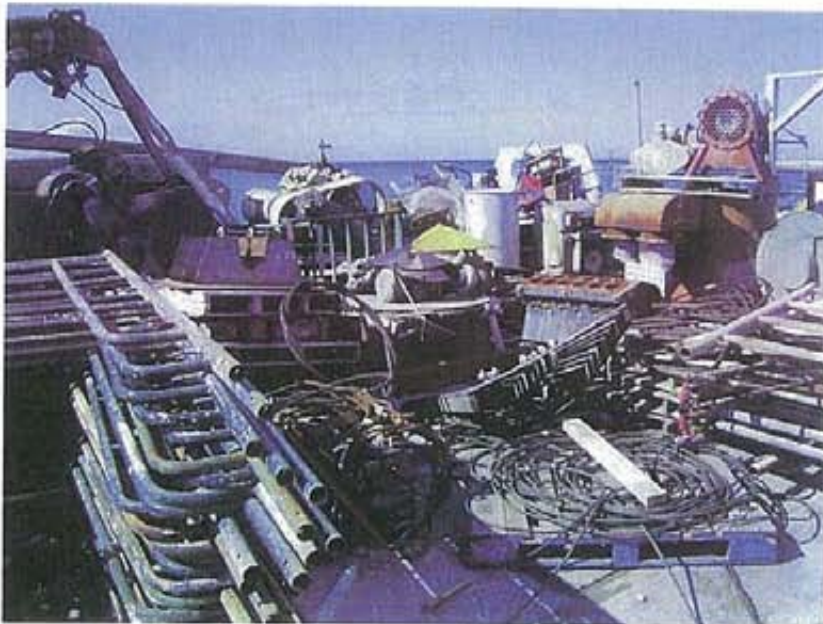
Photo 18: Material storage on the northwest end of the main yard. Engines, pumps, and other equipment were observed in this area.

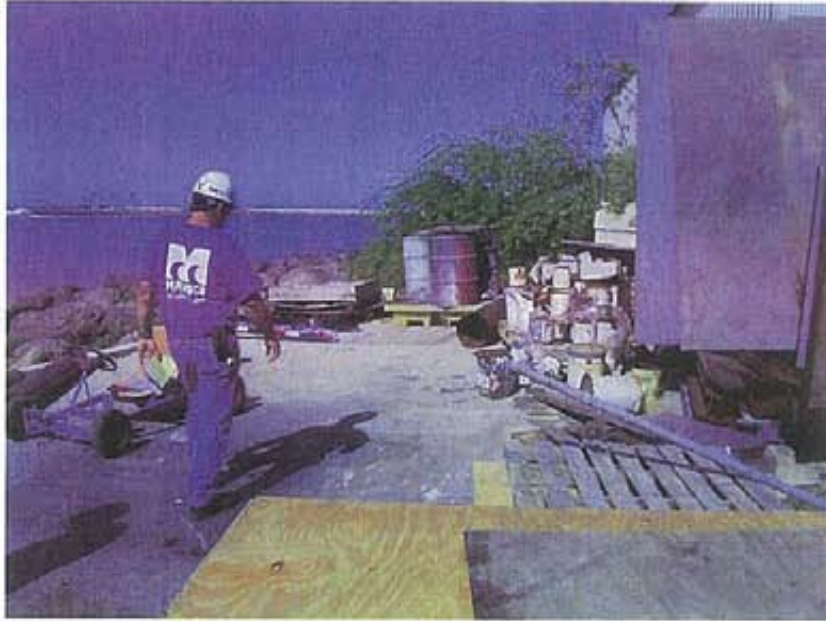
Storage Area Behind Main Yard

Photo 19: An area northwest of the main yard, behind the metal working building appears to be used for material storage. Materials stored in this area include paint, zinc anodes, and 55-gallon drums. This area does have a containment berm, which directs all storm water to a storm water discharge location pictured in Photo Nos. 23 and 24. A pallet of paint cans was observed stored on-site, exposed to potential rainfall, and in the direct drainage area to a storm water outfall.

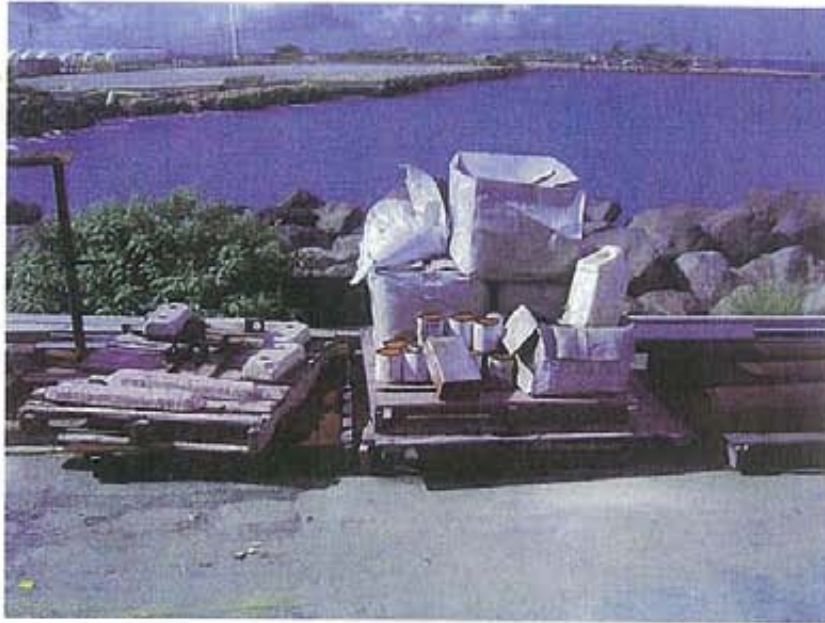
Photo 20: Additional cans of paint and zinc anodes were observed stored behind the metal working building, southwest of the main yard, exposed to potential rainfall and in the direct drainage area to a storm water outfall.

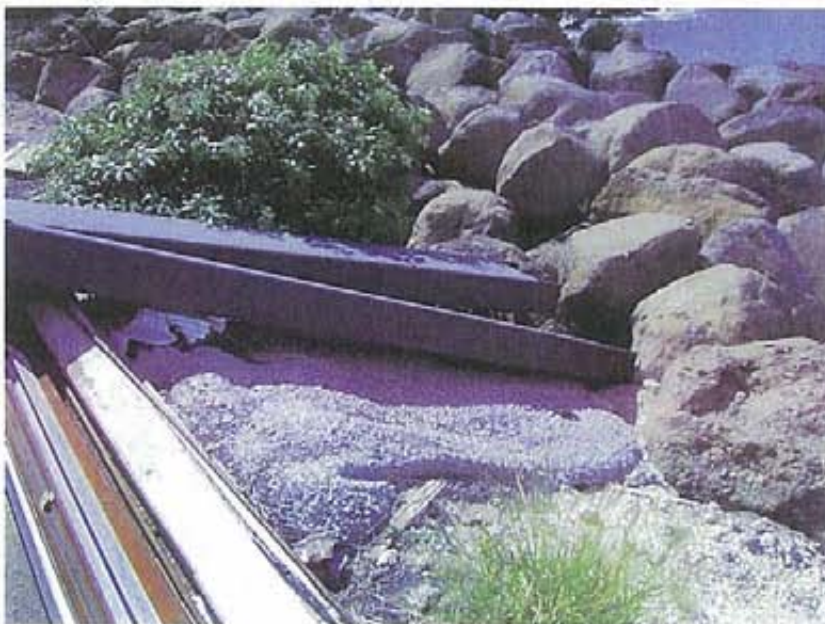
Photo 22: Evidence of concrete spillage from an on-site construction activity (possibly the construction of the concreted area itself or the berm) toward the receiving water. It is unclear if any of the concrete actually entered the receiving water. However this photo demonstrates a lack of effective best management practices utilized for the construction project by the Discharger this close to the edge of the receiving water.

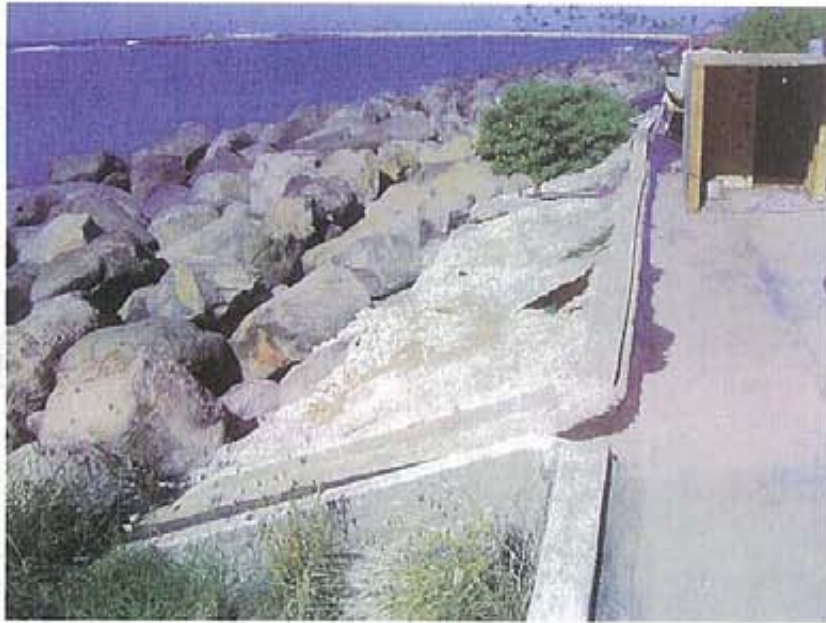
Photo 23: During the inspection, a storm water discharge location for the concrete area behind the metal working building was observed. Zinc anodes and paint cans are stored in this location. In addition, two dogs were observed chained in this area. Later in the day, a worker was observed hosing down the area toward the storm water outfall. Wash water runoff is visible discharging down the outfall.

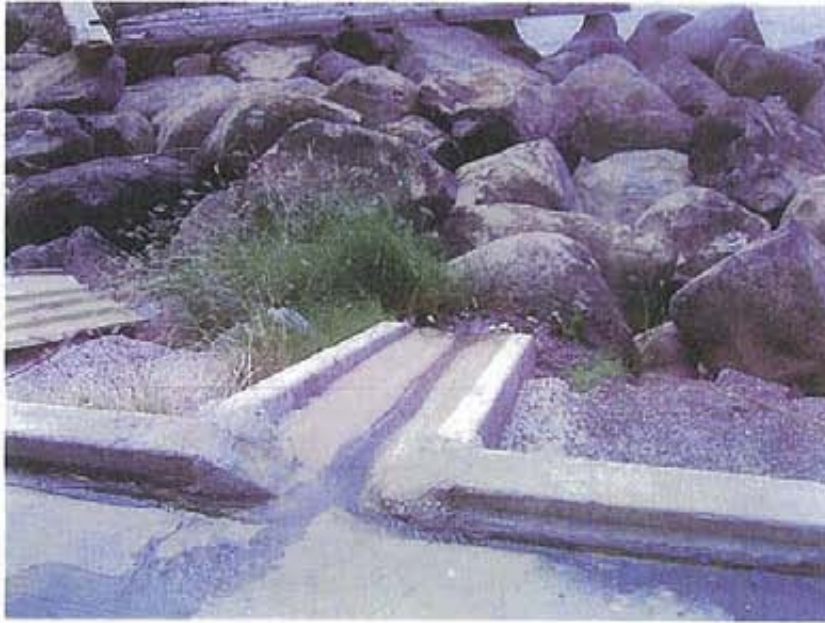
Photo 24: Another photograph of the storm water outfall for the area behind the metal working building. Wash water runoff is visible discharging down the outfall.

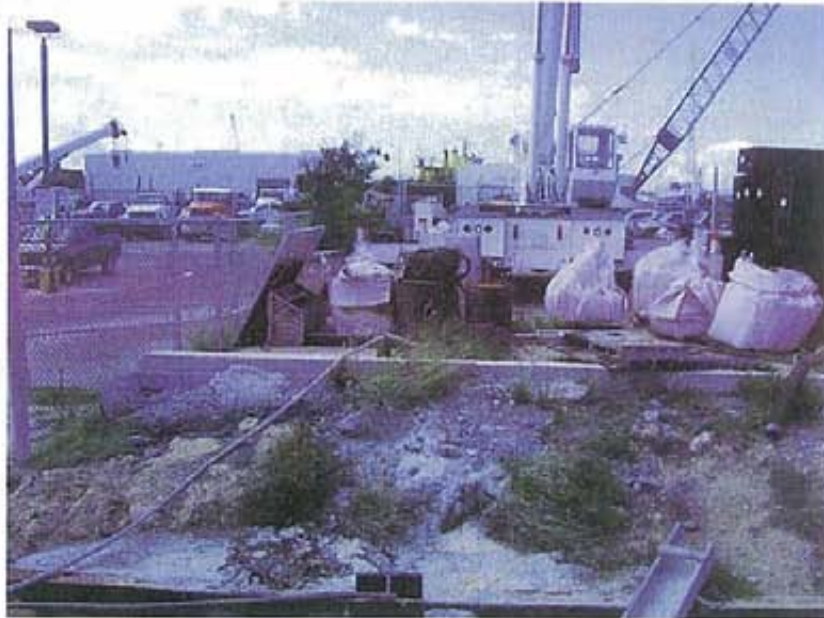
Photo 25: A view from the on-site working barge of the storage area at the southeast end of the main yard. This area was referred to by the Facility representative as "JR's Area". This area has a berm, with identified discharge locations (at the south end of the berm or left side of the photograph, and a gap in the berm to the right where the photograph cuts off). Materials observed stored in this location include used sand blasting grit, heavy equipment, petroleum products, and paint waste (what appeared to be a mixture of paint and paint thinner).

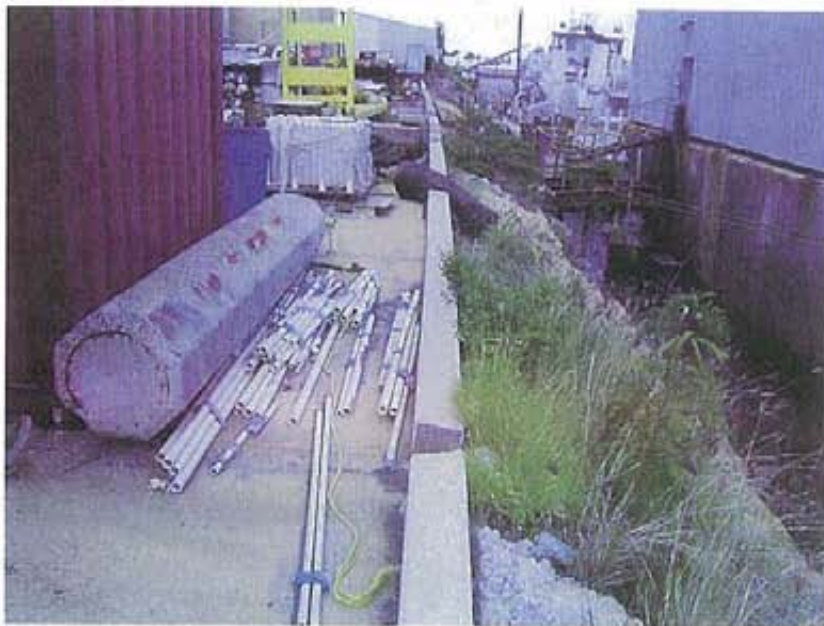
Photo 27: A gap in the berm surrounding JR's area. Discharges through this gap would flow down the bank and directly into the receiving water.

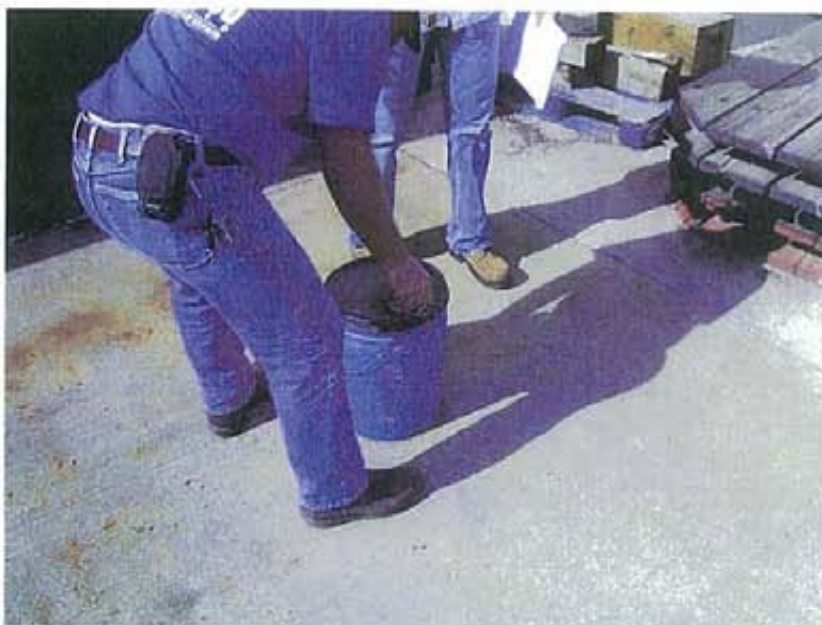
Photo 28: This photograph shows a 5-gallon bucket of motor oil (as identified by the Facility representative) in "JR's Area", without secondary containment.

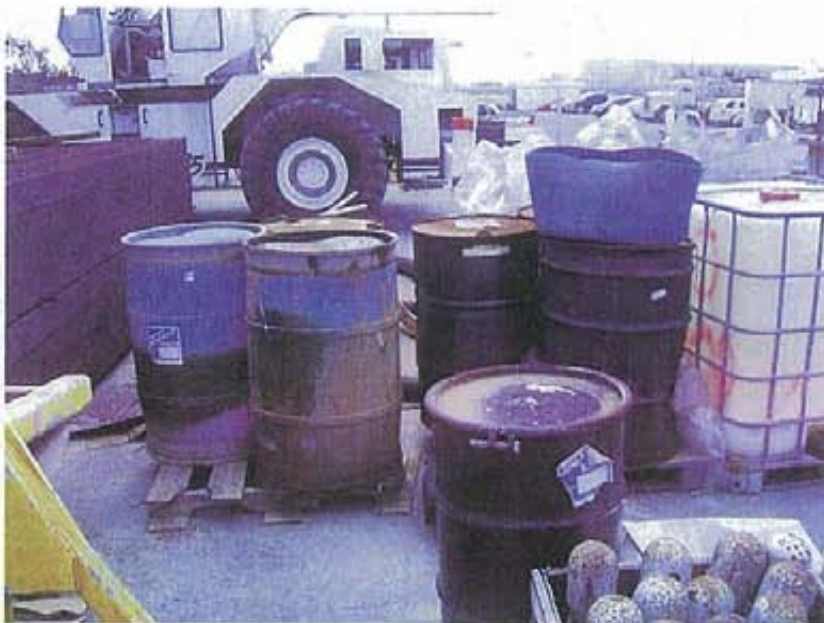
Photo 29: Three of the 55-gallon drums pictured (and labeled) above appeared to contain petroleum products, including motor oil and diesel fuel. These drums are not in a contained area, do not have secondary containment, and are exposed to potential rain fall.

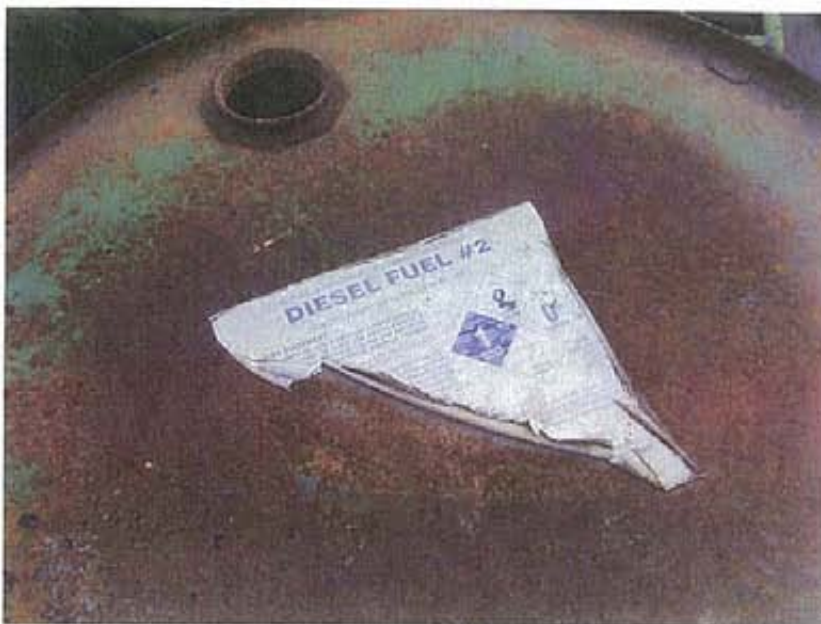
Photo 31: One of the three drums referenced above.

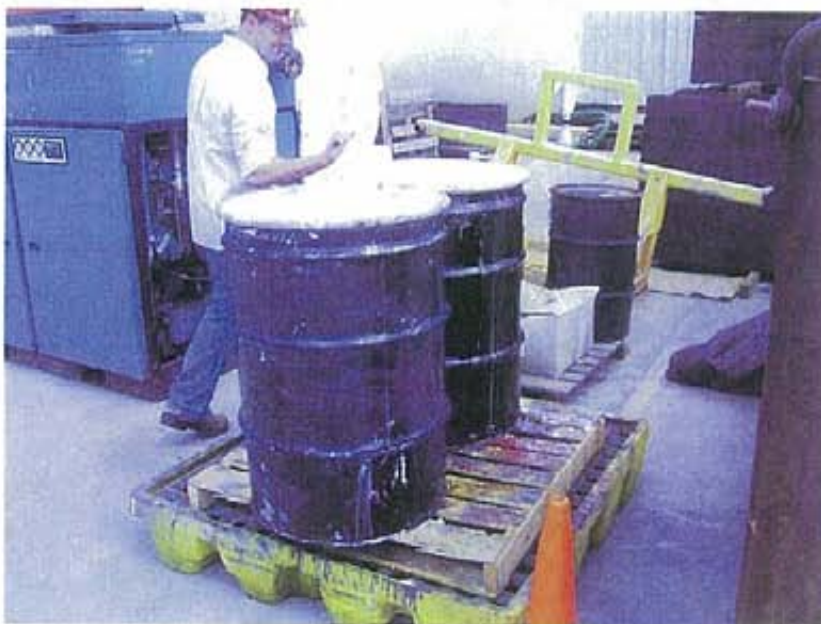
Photo 32: Two 55-gallon drums of "paint related waste" (as described by the Facility representative), which appeared to be a mixture of paint and paint thinner were stored on a secondary containment pallet, in "JR's Area", outside the designated hazardous waste storage area. The drum pictured above was opened by the Discharger at the inspector's request (as shown in Photo 31). One of the drums was hanging over the edge of the containment pallet.

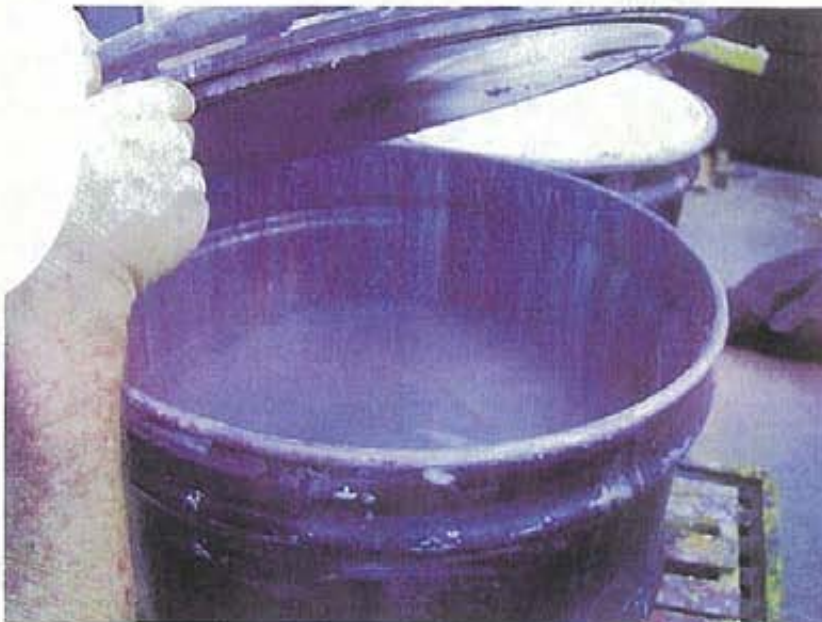
Photo 33: A photograph of the substance inside one of the two 55-gallon drums described in Photo 32. The drum pictured above was opened by the Discharger at the inspector's request.

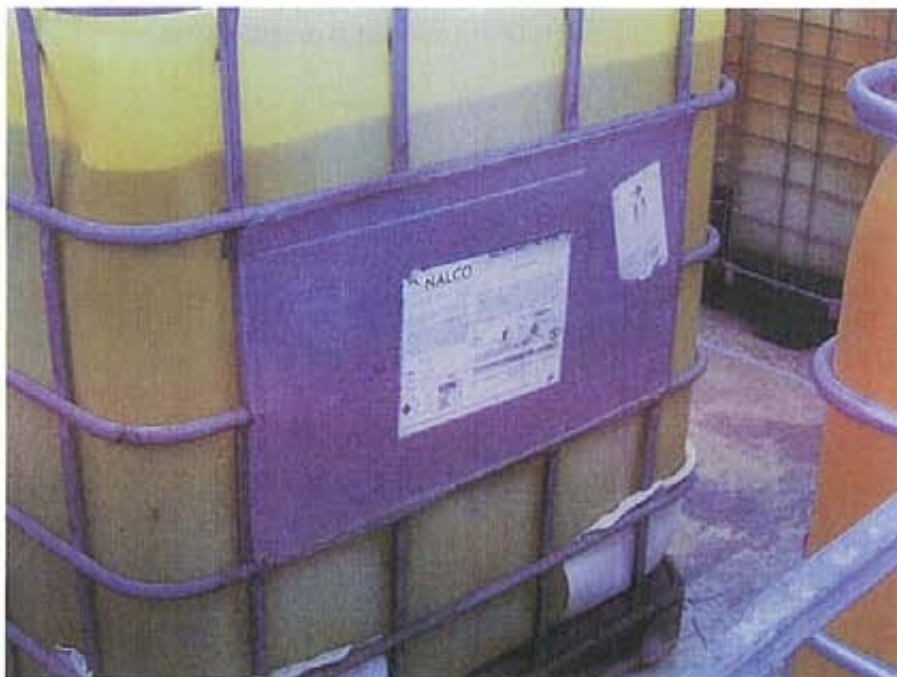
Photo 35: A tote originally used for flocculent was being used to store diesel fuel, without secondary containment. The tote was labeled as flocculent.

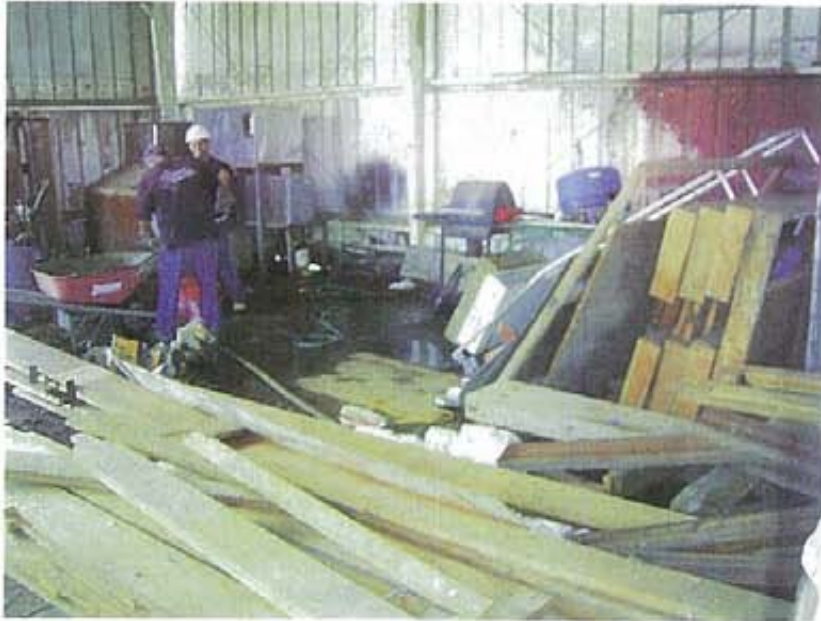
- d. Two workers were observed mixing cement on the work barge. Wet cement was observed on the ground of the work barge. Runoff from the cement mixing was observed running under the wall and down the side of the work barge into the receiving water;

Photo 37: Two workers were observed mixing cement on the work barge. Wet cement was observed on the ground of the work barge. Runoff from the cement mixing was observed running under the wall and down the side of the work barge into the receiving water, as shown in Photo No. 39.

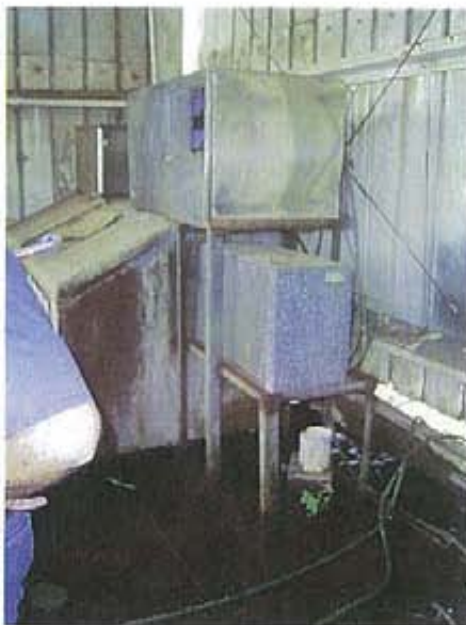
Photo 38: A closer photograph of the runoff from the cement mixing going under the wall of the work barge. Further, the Facility representative stated that condensate from the ice maker discharges under the wall and over the side of the work barge as well.

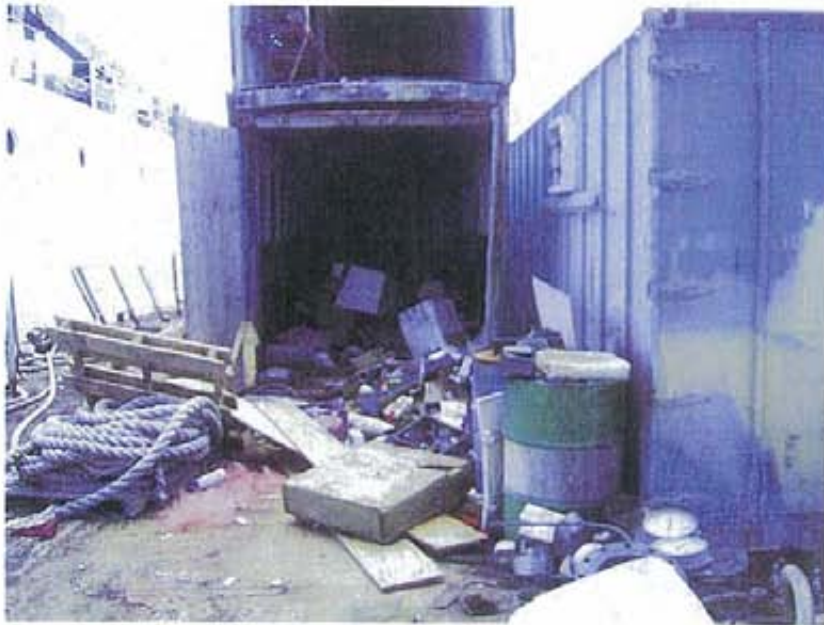
Photo 41: Debris and materials scattered on the floor of the work barge outside a storage shed. Two 55-gallon drums of oil were observed on the deck of work barge, without secondary containment.

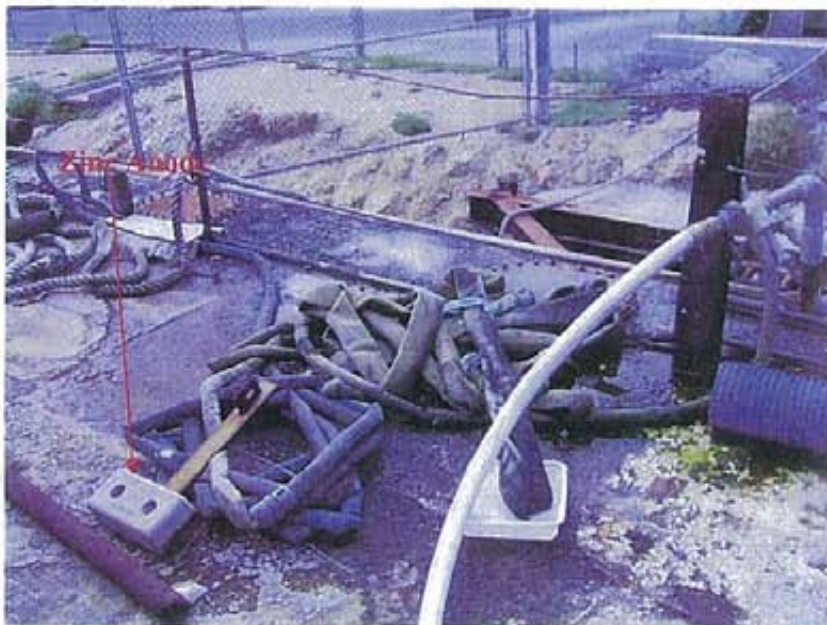
Photo 43: These water lines are used to supply the workers with potable water as they work on-board vessels. The line/hose hook ups were observed leaking and draining over the edge of the work barge. Also pictured above is a zinc anode on the deck of the work barge, near the draining water.

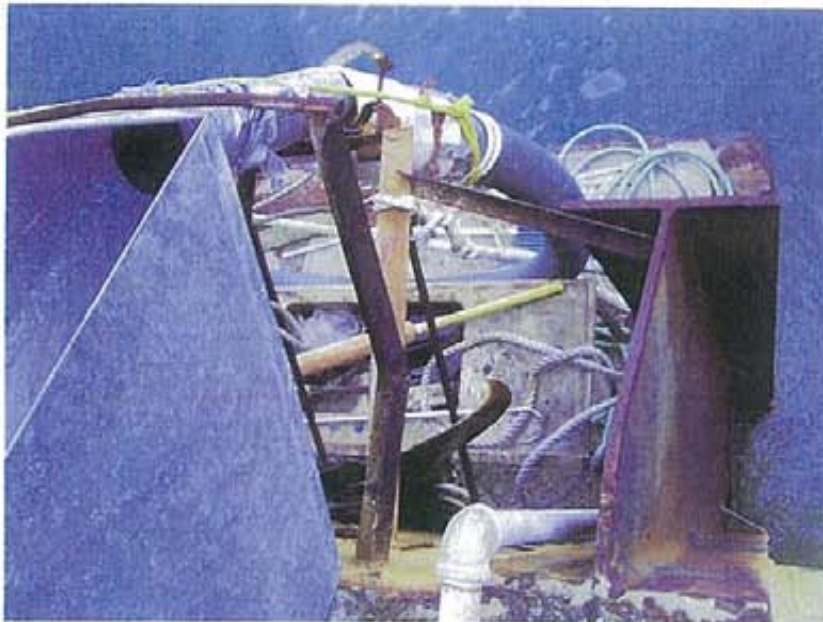
- e. A sink was observed on the stern of the work barge. The Facility representative stated that the sink was used for washing hands and cleaning fish and that he believed that the sink discharges directly into the harbor below; and

Photo 45: A sink was observed on the stern of the work barge. The Facility representative stated that he believes the sink discharges directly into the harbor below. The Facility representative stated that the sink is used for washing hands and cleaning fish. Due to the location of the sink, it was not possible to confirm the discharge location of the sink.

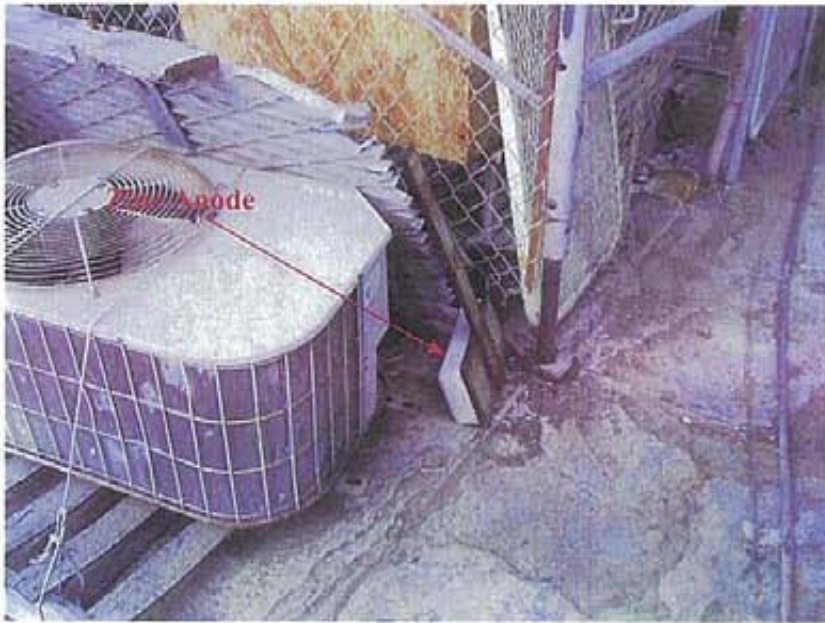
Photo 46: Another zinc anode observed on the deck of the work barge, exposed to potential storm water runoff.

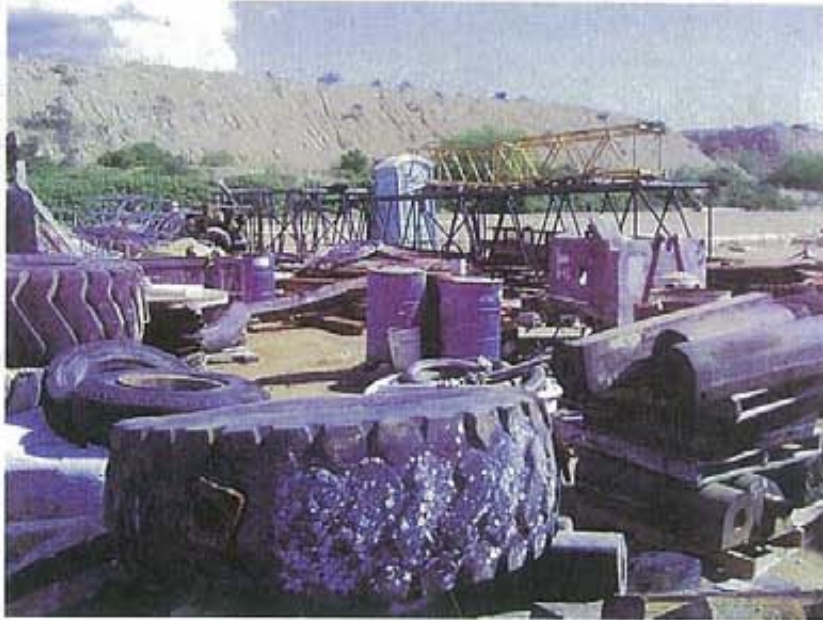
Photo 47: The photograph above is an overview of the northeast portion of the shore side staging area for the Lil' Parris dry dock. This area is used by the Discharger for storing materials for work performed on the dry dock. Materials stored in this area include scrap metal, old tires, cables, and machinery. Other materials are stored on-site in covered sheds.

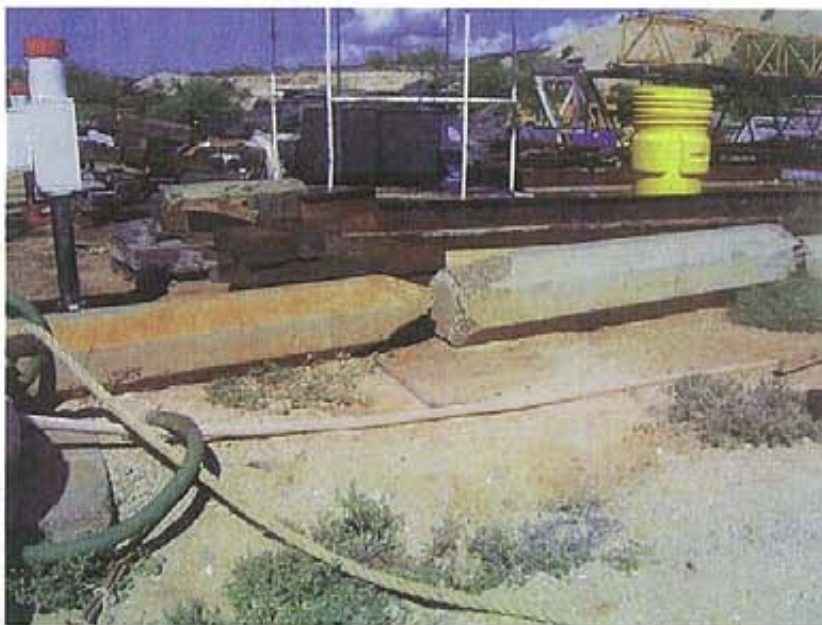
Photo 48: The shore side staging area for the Lil' Perris dry dock has a berm built from cement pillars. Plastic sheeting has been laid down against the pillars and covered with dirt, however the plastic sheeting has torn away in most areas and gaps are prevalent along the entire berm.

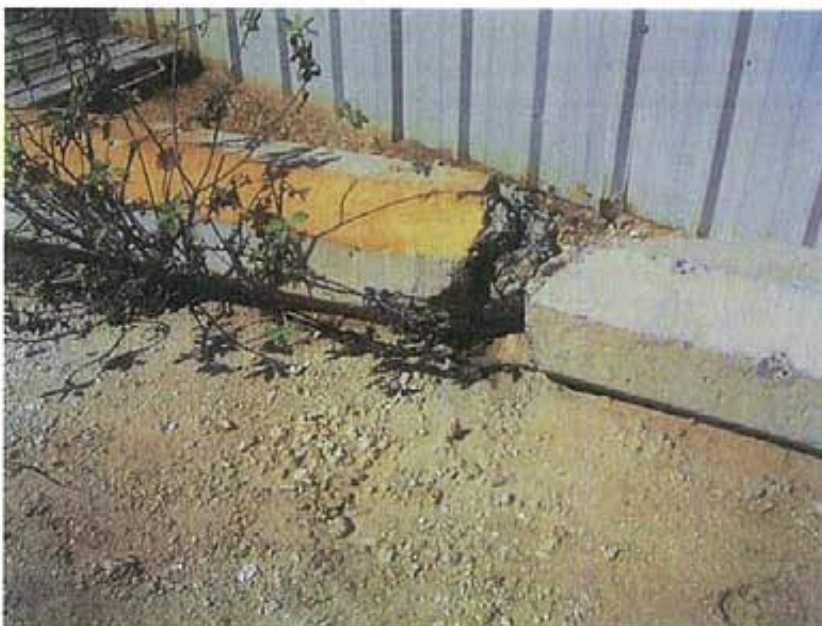
Photo 49: One of the gaps in the berm surrounding the shore side staging area for the Lil' Perris dry dock.

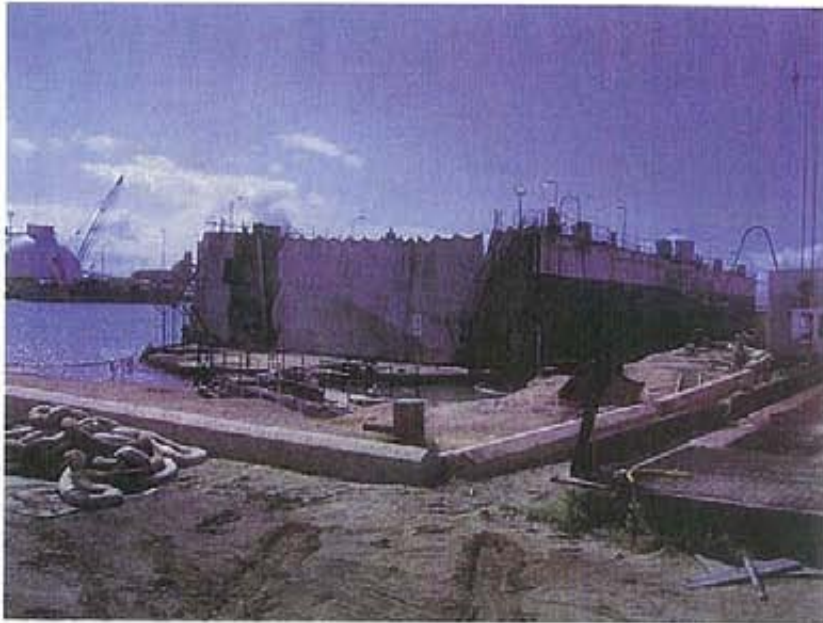
Photo 50: An overview of the Lil' Perris dry dock and the berm structure.

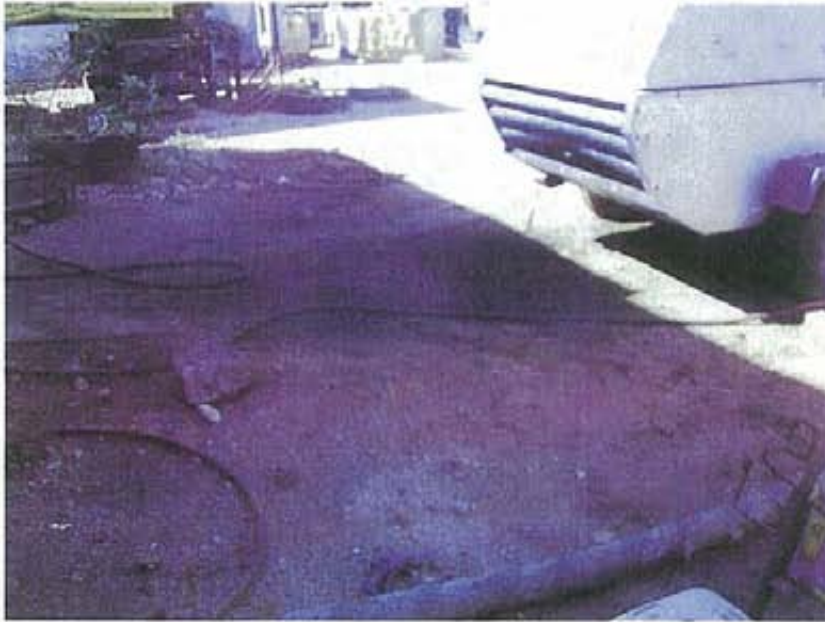
Photo 52: Staining of the ground by exhaust from an on-site air compressor.

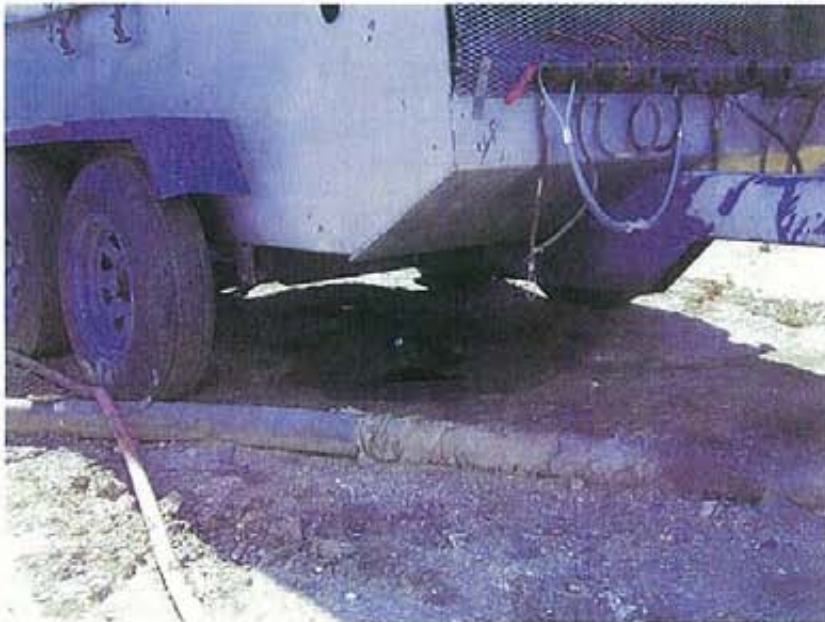
- ii. A mixture of oil and condensate was observed dripping directly on the ground from an air compressor on the shore side staging area beside the dry dock, inconsistent with Part B.2.j of the permit;

Photo 53: A mixture of oil and condensate dripping from the above pictured air compressor.
